ABERDEEN PROVING GROUND
MARYLAND

FIRST REPORT ON ASSAULT TANK T14

FIRST REPORT ON ORDNANCE PROGRAM NO. 5621

ORDNANCE RESEARCH CENTER
PROJECT NO. 1810

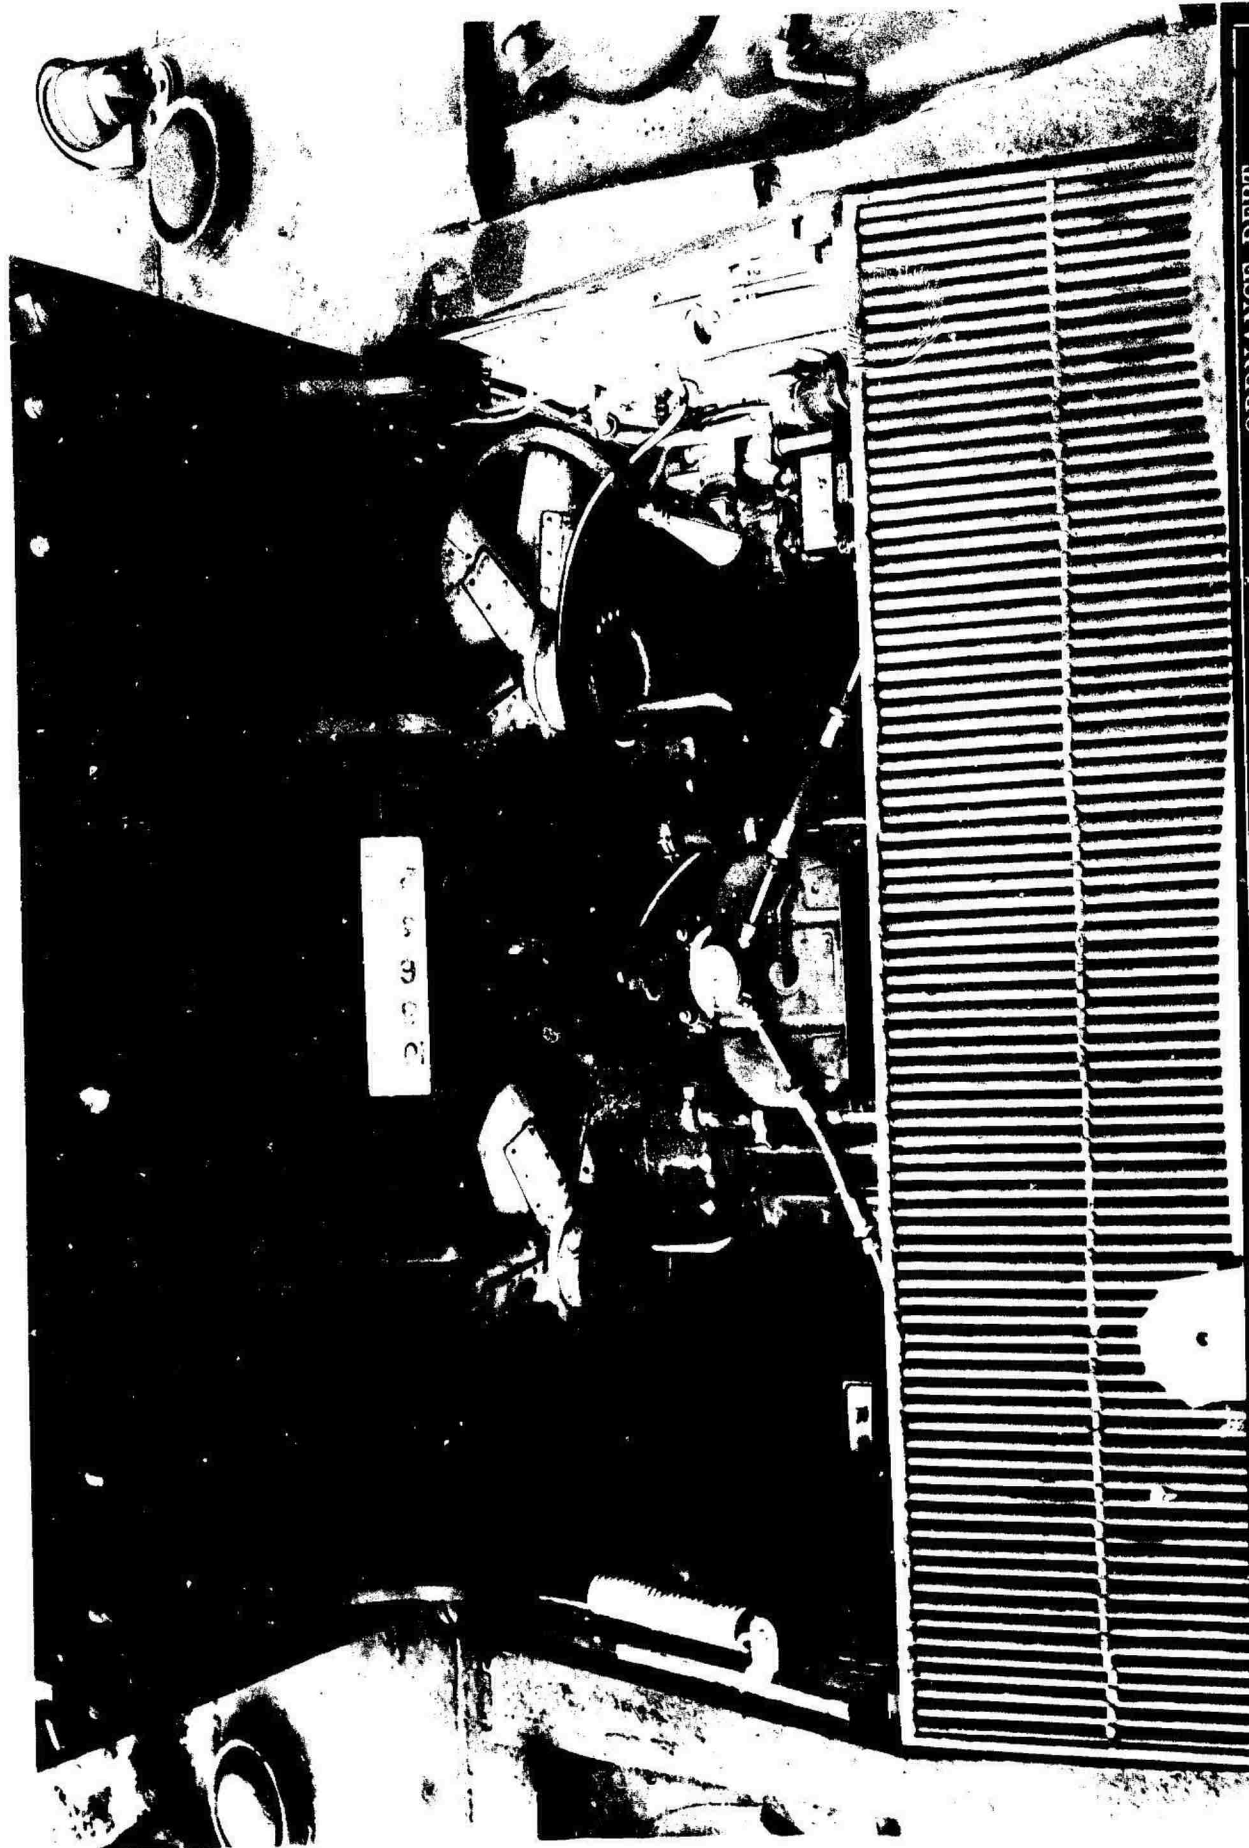
(1) When received, both Assault Tanks were equipped with the Autolite distributors shown in APG Photograph #93209. After brief operation of Assault Tank T14 #1 on the dusty course in the Palmer Area, however, it was found that this distributor became filled with dust in a very short time, which resulted in burned points and general malfunctioning of the distributor. See APG Photograph number 91234 in Appendix "A". The Autolite dust-proof distributor (see APG Photograph number 93208) was then installed. This latter distributor functioned quite satisfactorily for the remainder of the test operation, although it was not 100% dust-proof, as shown in APG Photograph number 92919.

K. C. - - - Asst. Turk., Tll.. Dirt in distributor, 46 miles after cleaning.

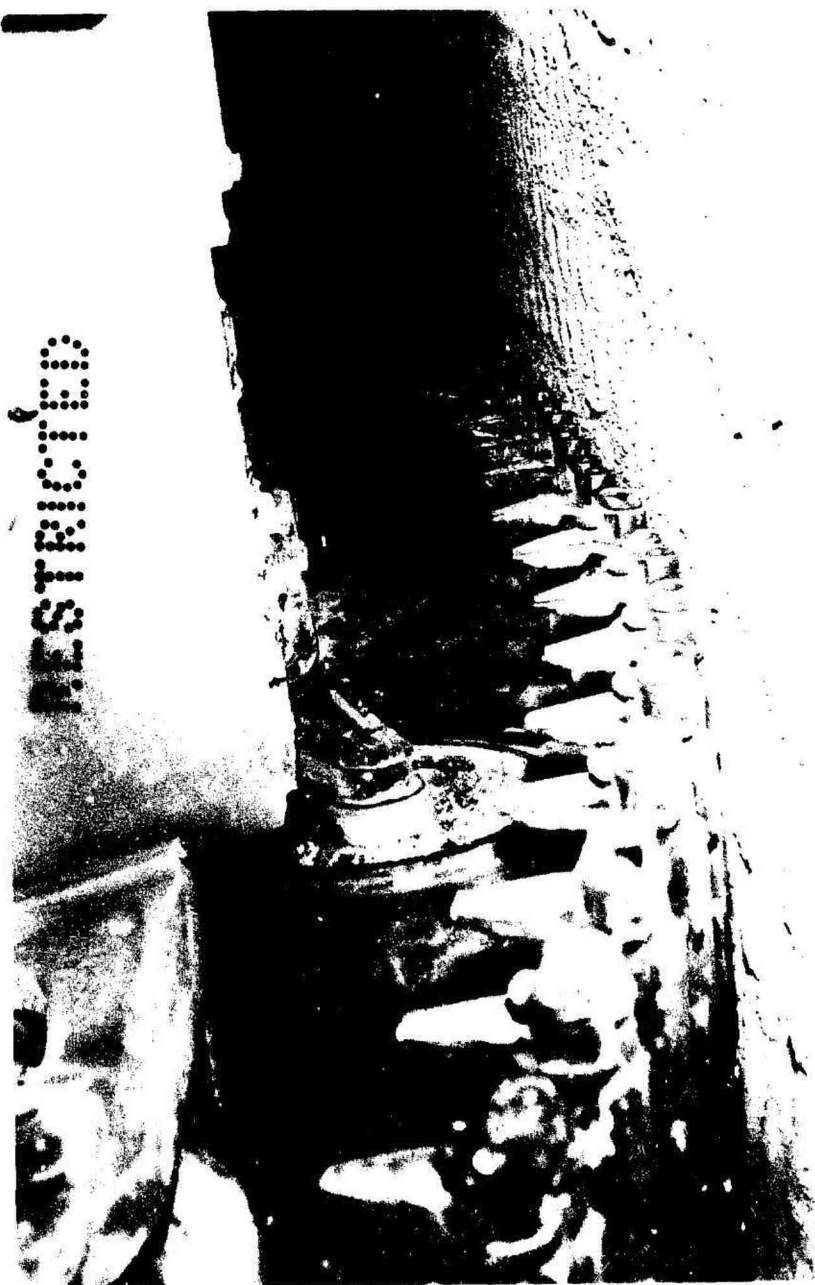
RESTRICTED - Proj. 3-11-2. A scout tank, T14 (Pilot #1). Left track thrown off on side slope while making left turn. View of under side of track.

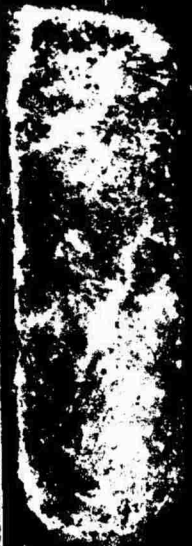
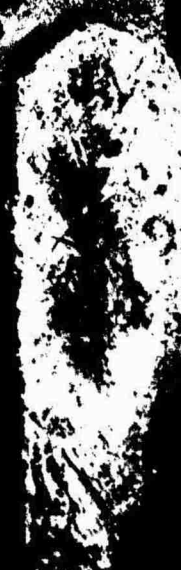
d. One track block was broken during the test of the first pilot vehicle. See APG Photograph number 92096 in Appendix "A". It is believed that the failure was caused by a combination of tight tracks and hard road operation.

RESTRICTED - Proj. 3-14-1. Assault Tank, T14, #1. Broken track block, left track.

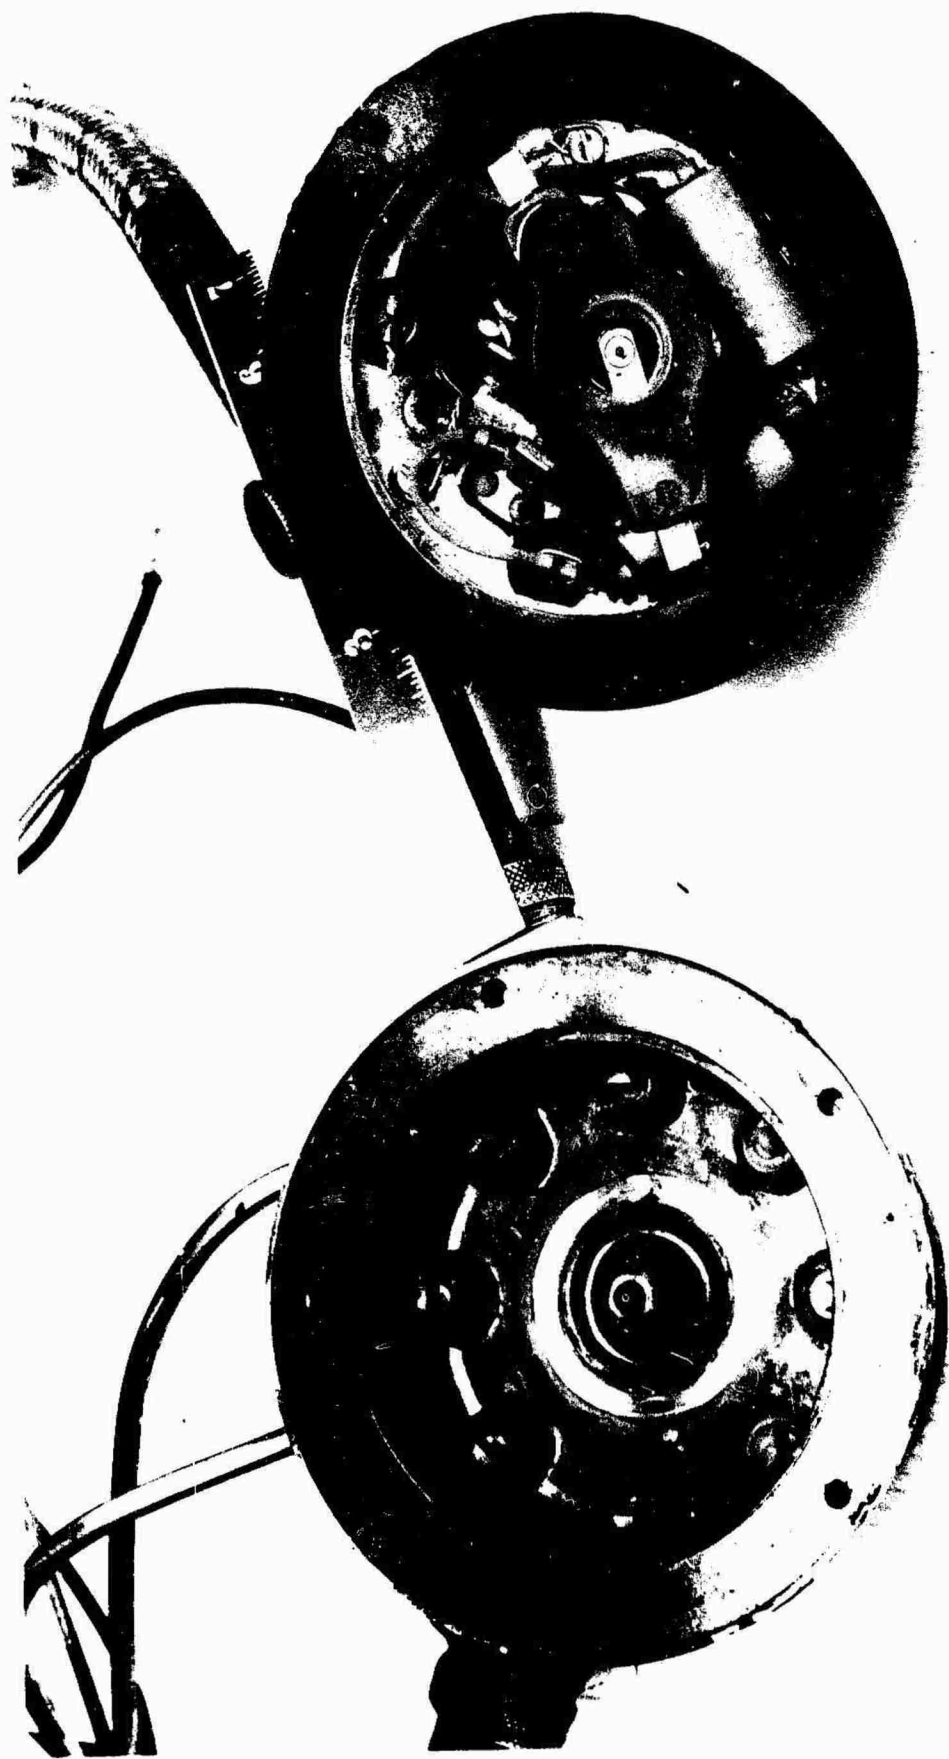
(9) The Dust-proof Autolite Distributor is not entirely dust-proof, but at no time during the test did sufficient dust enter the unit to cause malfunctioning.

Prod. 7-1-1. 4 in. Tank, T. 1. #1 (Pilot). Dust proof distributor removed after approximately 65 miles of cross-country operation. Distributor mfg. by Ahlrite.
